AGENDA
PLANNING COMMISSION
CITY OF LAKEWOOD
12650 DETROIT AVENUE
THURSDAY
FEBRUARY 5, 2026

**6. Docket No. 02-04-26
Communication from Planning and Development Staff
Madison Ave. and Hilliard Road Safety Analysis Study**

Madison Ave & Hilliard Rd/Carabel Ave Safety Analysis Study

Final Version
January 2026

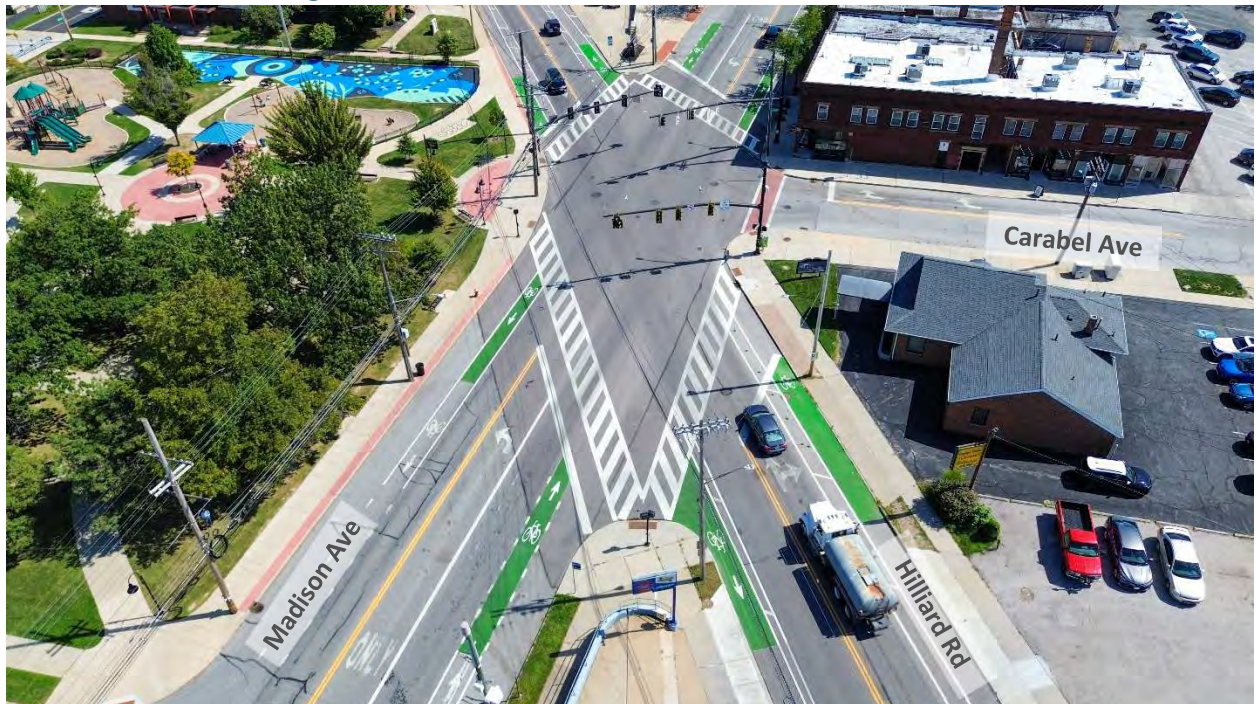
Figure 2 – Madison Ave & Hilliard Rd/Carabel Ave Aerial View

Madison Ave and Hilliard Rd/Carabel Ave is a five-leg signalized intersection. Madison Ave is an east to west corridor that extends through the entire City. Hilliard Rd is a northeast to southwest corridor that starts in the southwest portion of the City and extends northeast to Franklin Blvd/Warren Rd. Figure 2 is an aerial image of the existing intersection.

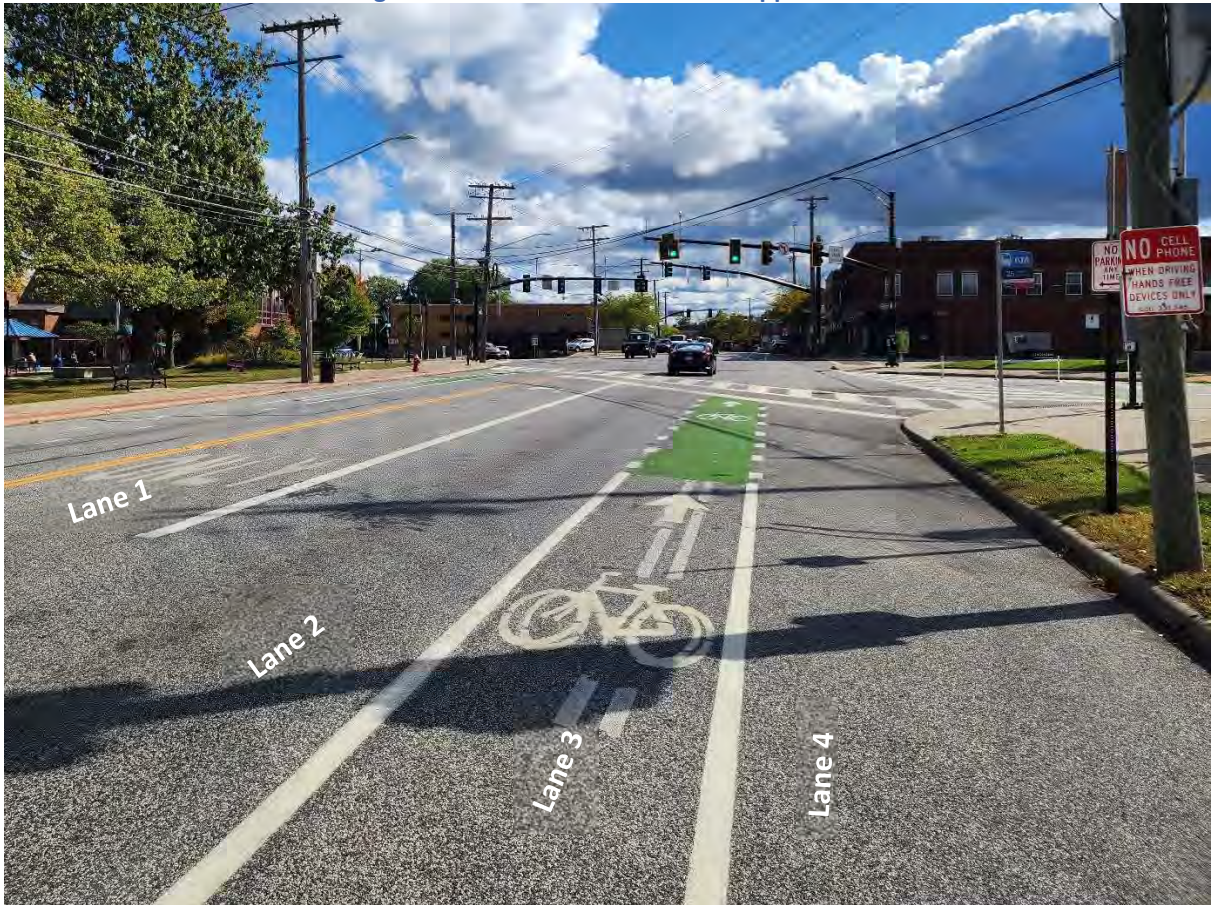
Figure 3 – Madison Ave Eastbound Approach

- Madison Ave Eastbound Approach (refer to **Figure 3**)
 - **Lane 1** (inside): Exclusive left-turn only lane, developed from the upstream two-way left-turn lane (TWLTL), approximately 11' wide.
 - **Lane 2** (middle): Shared through/right-turn lane, approximately 11' wide.
 - **Lane 3** (outside): Exclusive bicycle lane, extending to the intersection stop line and is approximately 4' wide. The bicycle lane is channelized with a solid white line and transitions to a skip line approximately 130' away from the stop bar.
 - **Lane 4** (curbside): Exclusive on-street parking lane, located to the right of the bicycle lane.
 - The eastbound left turn is a 5-section protected/permissive left turn movement.
 - The approach is signed to prohibit right turns on red.

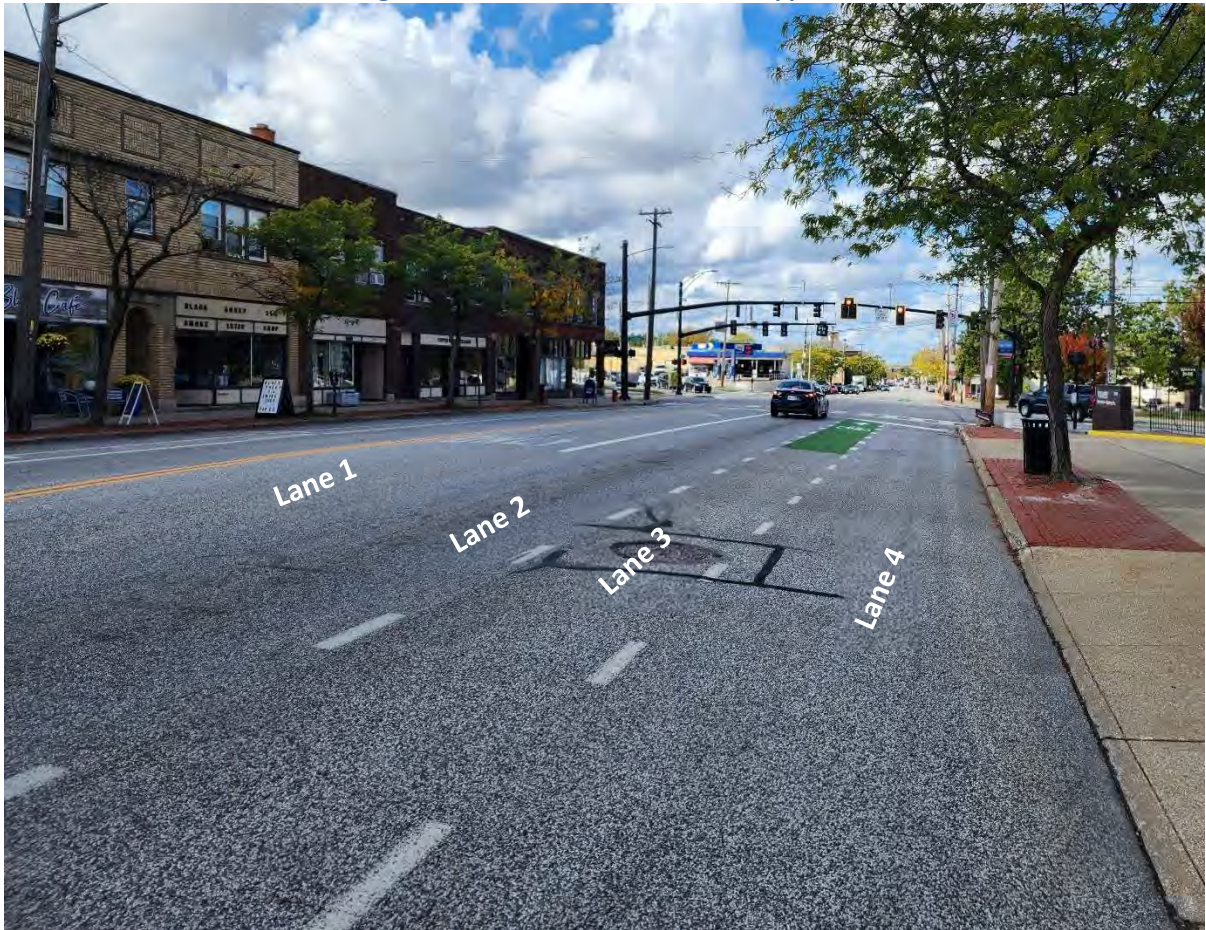
Figure 4 – Madison Ave Westbound Approach

- Madison Ave Westbound Approach (refer to **Figure 4**)
 - **Lane 1** (inside): Exclusive left-turn only lane, developed from the upstream two-way left-turn lane (TWLTL), approximately 11' wide.
 - **Lane 2** (middle): Shared through/right-turn lane, approximately 11' wide.
 - **Lane 3** (outside): Exclusive bicycle lane, extending to the intersection stop line and is approximately 4' wide. The bicycle lane is channelized with a solid white line and transitions to a skip line approximately 130' away from the stop bar.
 - **Lane 4** (curbside): Exclusive on-street parking lane, located to the right of the bicycle lane.
 - The westbound left turn is a 5-section protected/permissive left turn movement.
 - The approach is signed to prohibit right turns on red.

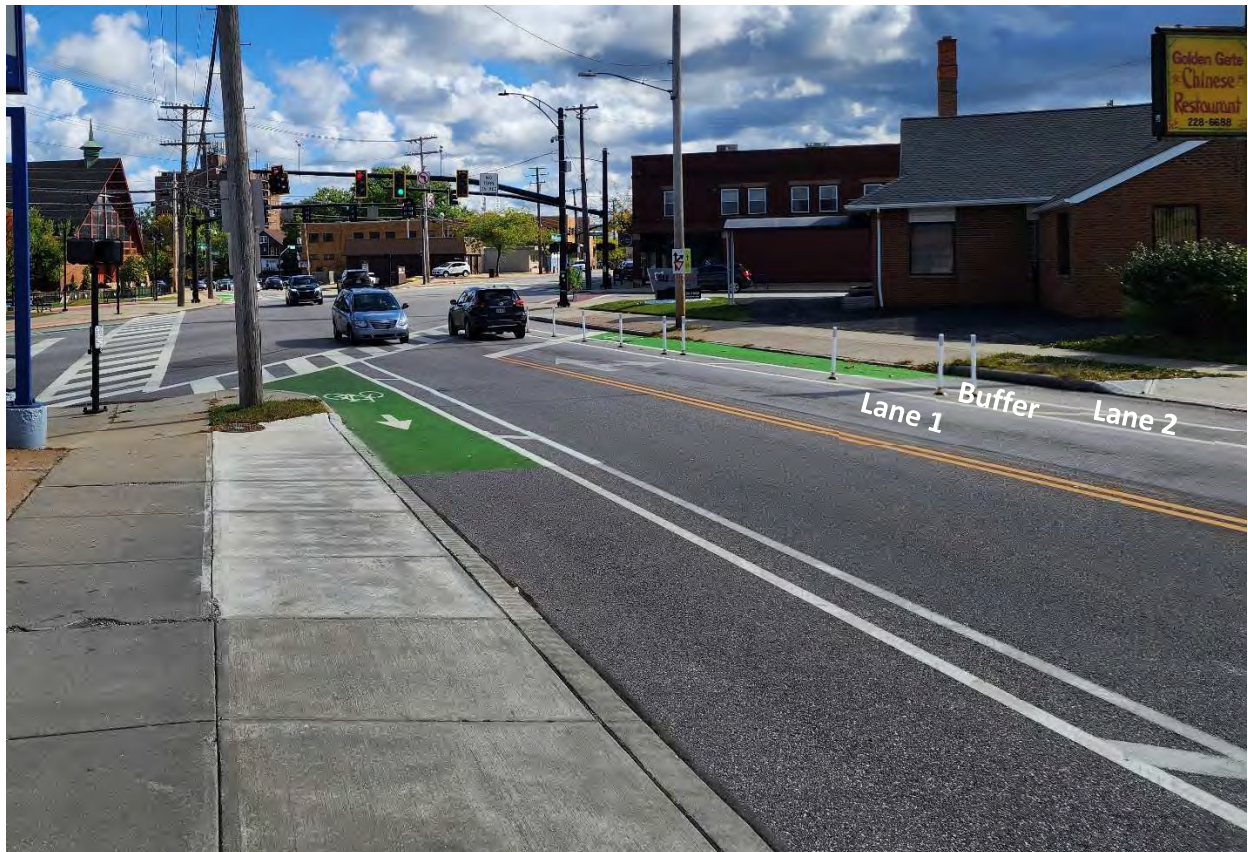
Figure 5 – Hilliard Rd Northeast Approach

- Hilliard Rd Northeast Approach (refer to **Figure 5**)
 - **Lane 1** (inside): Single lane for the through and shared with the right turn movement. Left turn and U-Turn movements are prohibited.
 - **Lane 2** (curbside): A dedicated bicycle lane approximately 4 feet wide, extending to the intersection stop line. It includes a 2-foot painted buffer separating it from the adjacent through/right vehicle lane. Near the intersection, the lane is highlighted with green pavement markings. Flexible delineators have been installed by the City in the buffer lane to provide physical separation between the bike lane and the adjoining travel lanes.
 - The approach is signed to prohibit right turns on red.

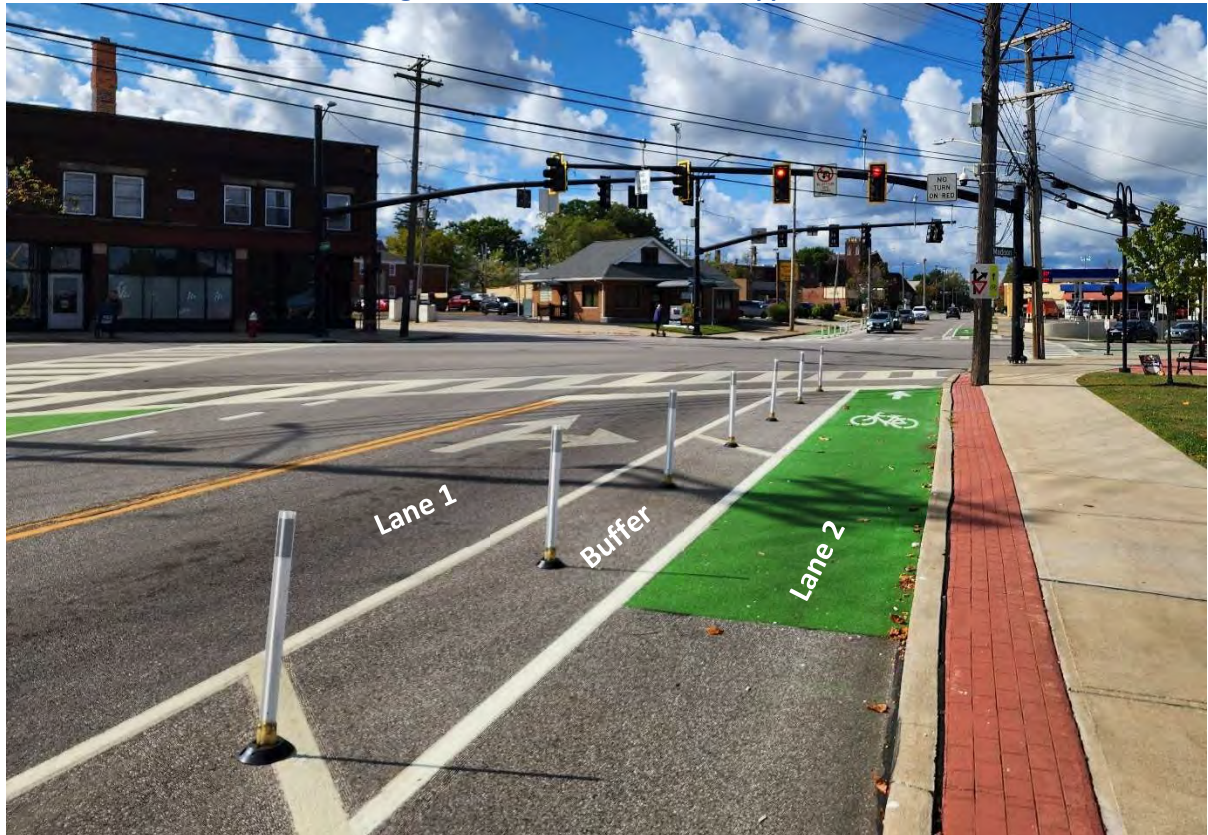
Figure 6 – Hilliard Rd Southwest Approach

- Hilliard Rd Southwest Approach (refer to **Figure 6**)
 - Lane 1 (inside): Single lane for the through and shared with the right turn movement. Left turns and U-Turn movements are prohibited.
 - Lane 2 (curbside): A dedicated bicycle lane approximately 4 feet wide, extending to the intersection stop line. It includes a 2-foot painted buffer separating it from the adjacent through/right vehicle lane. Near the intersection, the lane is highlighted with green pavement markings. Flexible delineators have been installed by the City in the buffer lane to provide physical separation between the bike lane and the adjoining travel lanes.
 - The approach is signed to prohibit right turns on red.

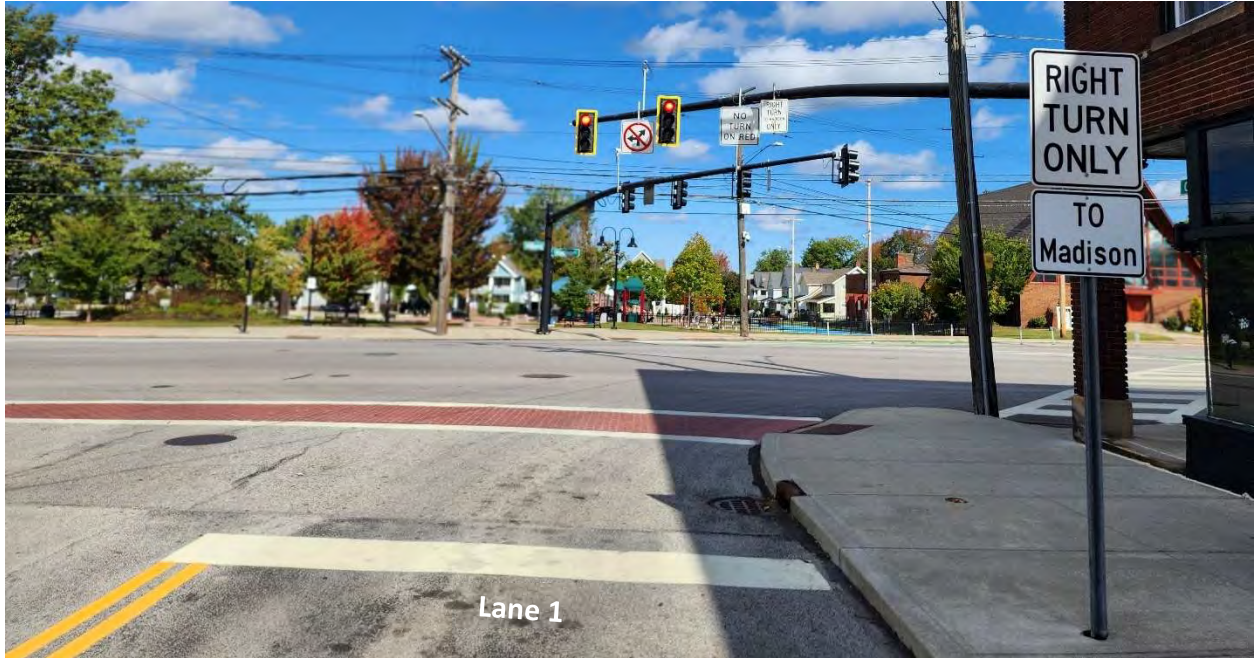
Figure 7 – Carabel Ave Northbound and Southbound

- Carabel Ave Northbound Approach and Southbound (refer to **Figure 7**)
 - **Lane 1:** Carabel Ave is a signal lane approach and only allows northbound right turns onto eastbound Madison Ave.
 - The northbound right movement operates during the same phase as the westbound left from Madison to Hilliard Rd/Carabel Ave.
 - The approach is signed to prohibit right turns on red.

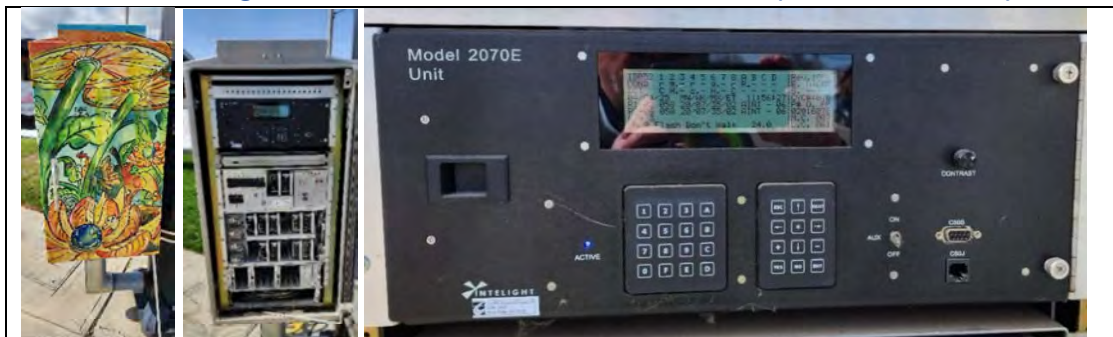
Figure 8 – Madison Ave & Hilliard Rd/Carabel Ave (2070 controller Unit)

Existing controller data was obtained from the City via an upload from the central platform, Trafficview 32. The intersection is a model 2070E with Wapiti firmware (see **Figure 8**). The existing signal layout and traffic signal phasing is shown in **Figure 9**.

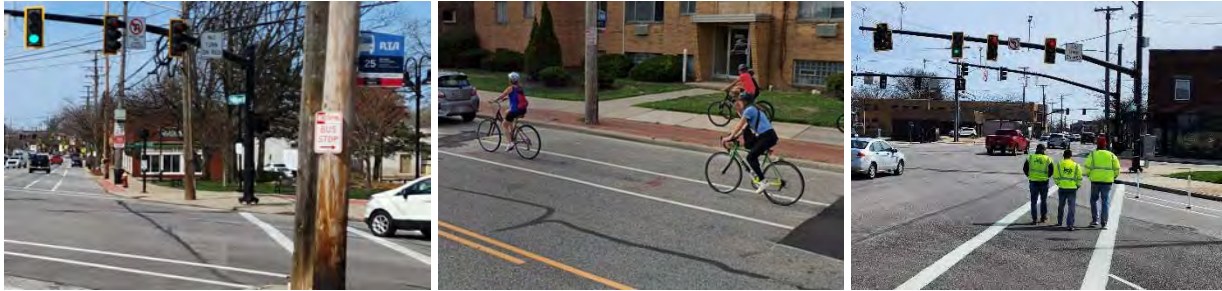
Figure 10 – Study Area Bus, Bicycle and Pedestrian Activity

The study area is very inviting to pedestrian activity with the land use mixes near the intersection from commercial, business, restaurants, community, recreational, school, and other attractions. On the northwest corner is Wagar Park. The adjacent land uses to the north and south is primarily residential. Sidewalks exist throughout the study area. Crosswalk pavement markings are currently present on all approaches and are transverse (parallel) white lines (see **Figure 10**).

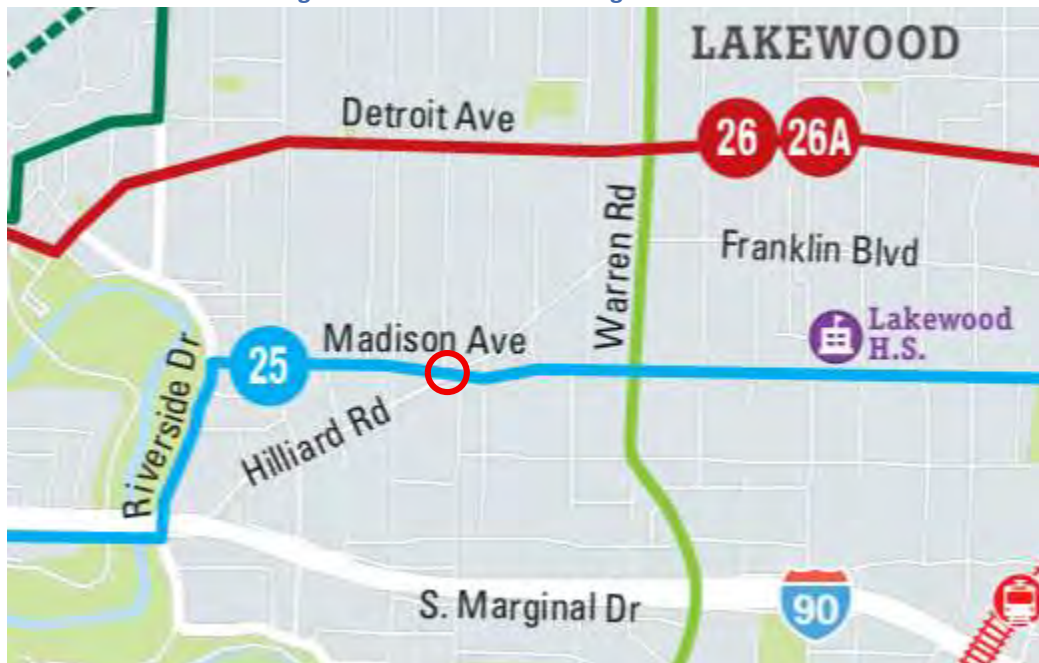
Figure 12 – RTA Route 25 along Madison Ave

Figure 12 illustrate these RTA routes in the study area.

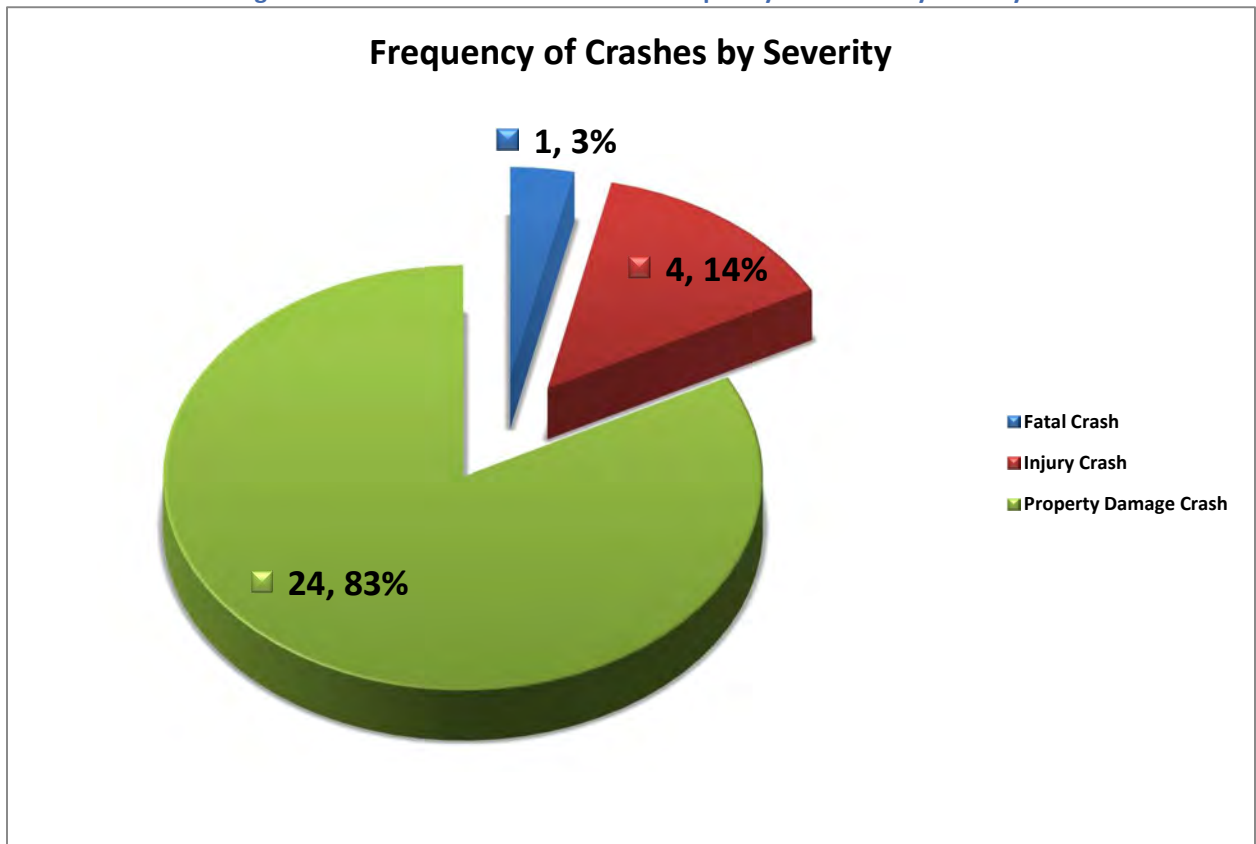
Figure 13 – Madison Ave & Hilliard Rd Frequency of Crashes by Severity

Crash severity is summarized as being fatal crash, injury crash, or property-damage crash. **Figure 13** illustrates the historical crashes by severity for the intersection.

The severity analysis illustrated the following:

- There was one fatal crash that occurred in 2024.
- Most of the study area corridor crashes are comprised of property damage only crashes, 83 percent of all crashes.
- Injury crashes were the second most common, 14 percent of all crashes.

Two of the serious crashes have raised significant safety concerns. In December 2024, a pedestrian was fatally struck while crossing Madison Avenue near the intersection, leading to criminal charges against the driver who was speeding. In March 2025, a vehicle collided with a bicycle pulling a child trailer carrying two young passengers, who sustained injuries; the driver was cited for failing to yield.

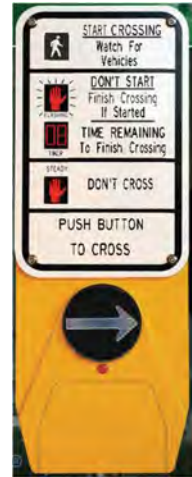
If LPI is implemented as recommended above, APS is highly desirable for visually impaired individuals as they use verbal cues from adjacent vehicles to know when the walk indication is on if there is no APS.

In general, this would be moderate cost provided additional structural items are not required, but this is not anticipated. APS is recommended, in particular with the addition of LPI.

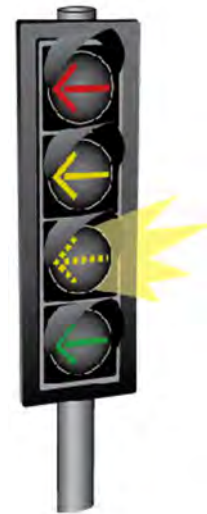
The FYA has been widely adopted and even encouraged by agencies across the United States. ODOT has embraced the use of the FYA and more information can be found here, <https://www.transportation.ohio.gov/programs/tsmo/signals/flashing-yellow-arrow>. The FYA indication would allow for the operation of an LPI for pedestrians crossing Hilliard Rd.

The cost of the FYA at the subject location should be moderate to high. The structure is capable of centering the new indication over the left turn lanes. However, the cabinet and controller would likely need to be updated.

If further investigation shows the installation of the FYA is possible without major changes, this type of operation is highly desirable for the reasons already stated.

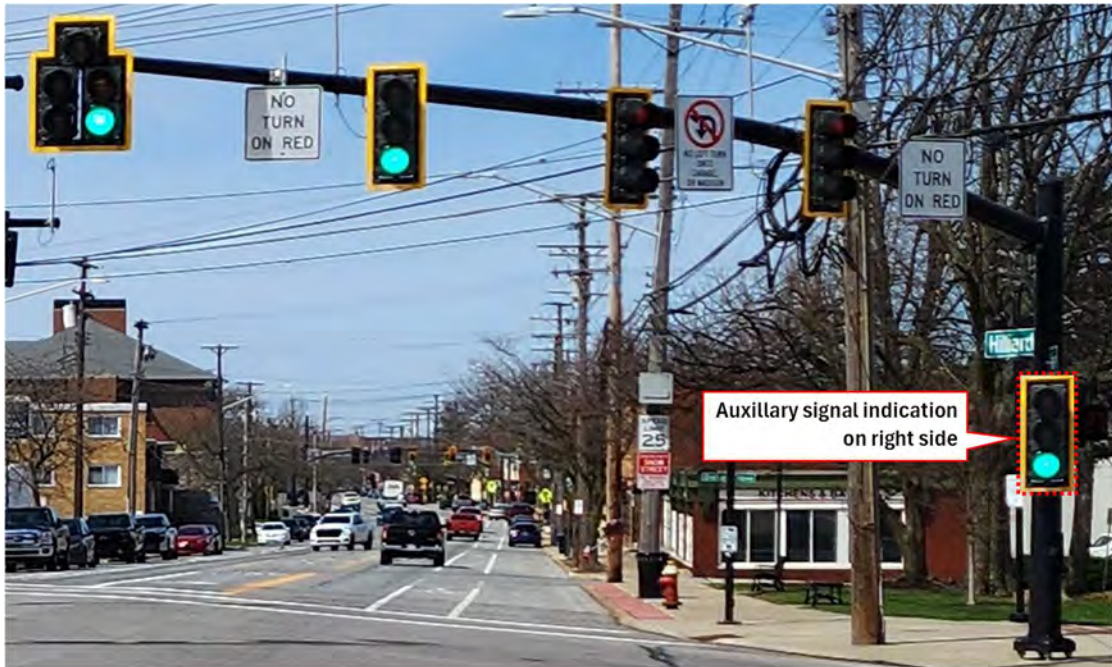
Figure 18 – Auxiliary Right Side Signal Indication

An auxiliary right side signal indication is installed on the right side upright of the traffic signal structure. Large trucks often block the view of the overhead signal indications and these auxiliary signals help improve visibility for these locations. Figure 18 illustrates the approximate location of a proposed auxiliary right side signal indication. These indications at this location could be misleading for opposing directions due to the skewed angle between Madison Ave and Hilliard Rd. These are not recommended for the short-term, but in the long term if signal structures are updated, these could be installed on near-side upright poles that would not be visible to the other approaches.

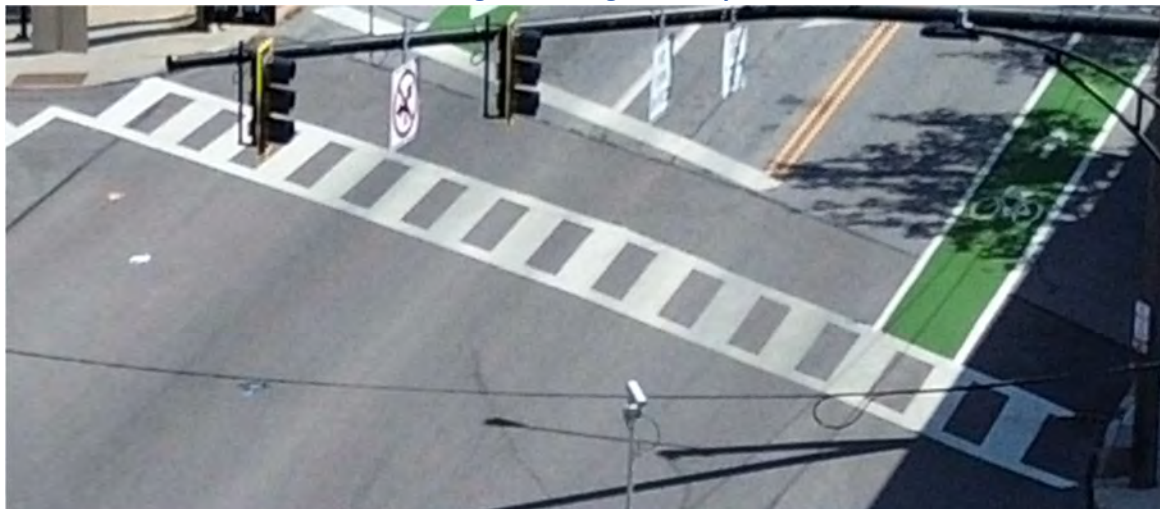
Figure 19 – High Visibility Crosswalk

High-visibility crosswalks use bold pavement markings—such as continental (bar) or ladder-style striping—that are more prominent to approaching drivers than standard parallel lines. These markings enhance pedestrian safety by increasing driver awareness of crossing activity, improving yielding compliance, and providing clearer guidance for pedestrians on where to cross. Research has demonstrated that high-visibility crosswalks can reduce pedestrian crashes at uncontrolled locations by up to 40 percent, making them a proven, cost-effective countermeasure for improving safety for vulnerable road users.
